STAINING OF BLUE BRICKWORK (peacocking & picture framing)

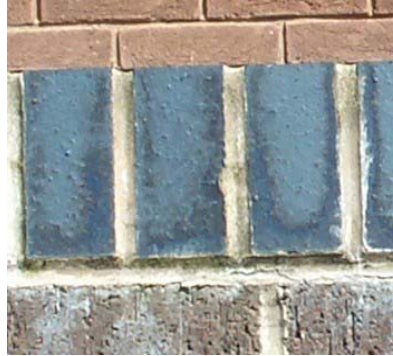
Picture Framing

a) Saturation of brickwork prior to the mortar curing. This gives a 'picture frame' effect, with the dark staining more apparent around the edges of the brick. Higher degrees of saturation may release free lime present in the mortar resulting in lime leeching from the joints.

To minimise the effects, good site practice should be adhered to following the recommendations in BS 5628: Part 3 'Code of Practice for Use of Masonry and BS 8000:Part 3.

Keep stacks of bricks and newly laid brickwork as dry as possible.

Clean the brickwork down at the end of the job with a proprietary brick cleaner containing a brick detergent.

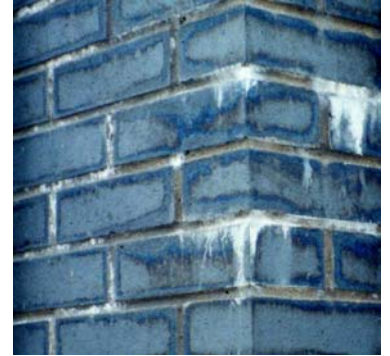
Staining

b) The direction of water run-off from cementitious areas, i.e. floor slabs.

c) A fine deposit of cement or lime transmitted to fine crazing lines by the moisture in the mortar at the time of laying.

All are superficial and are not detrimental to the performance of the brick. Changing weather conditions can highlight some of the effects as can the initial drying out of brickwork.

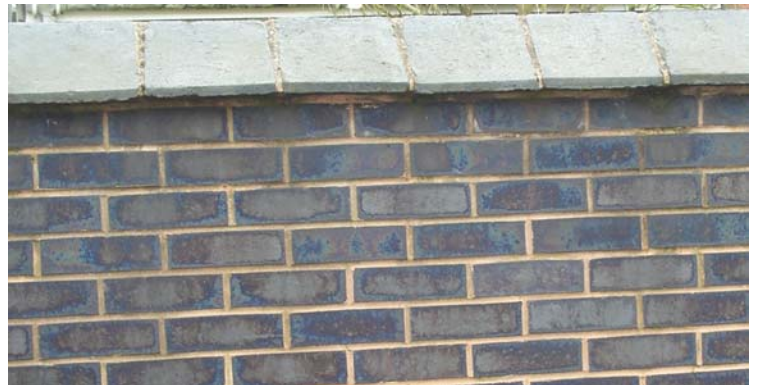
Peacocking

Blue bricks often exhibit an oily coloured type of stain, which may be referred to as 'Peacocking'. Stemming from the colours found in the feathers of the male Peacock and being similar to the swirling colours of oil on water, it has always been a normal feature of blue clay brickwork due to the iridescent effect of the brick's colour and is caused by light diffraction through a very thin surface layer of colloidal silica.
